A Rare Complication of the Percutaneous Intra-Aortic Catheter: Inadvertent Puncture during Surgery

Jeffrey D. Gough, Ronald J. Massimino, Gary T. Stearns, and John Martin, Jr.

Department of Clinical Perfusion
Rhode Island Hospital
Providence, Rhode Island

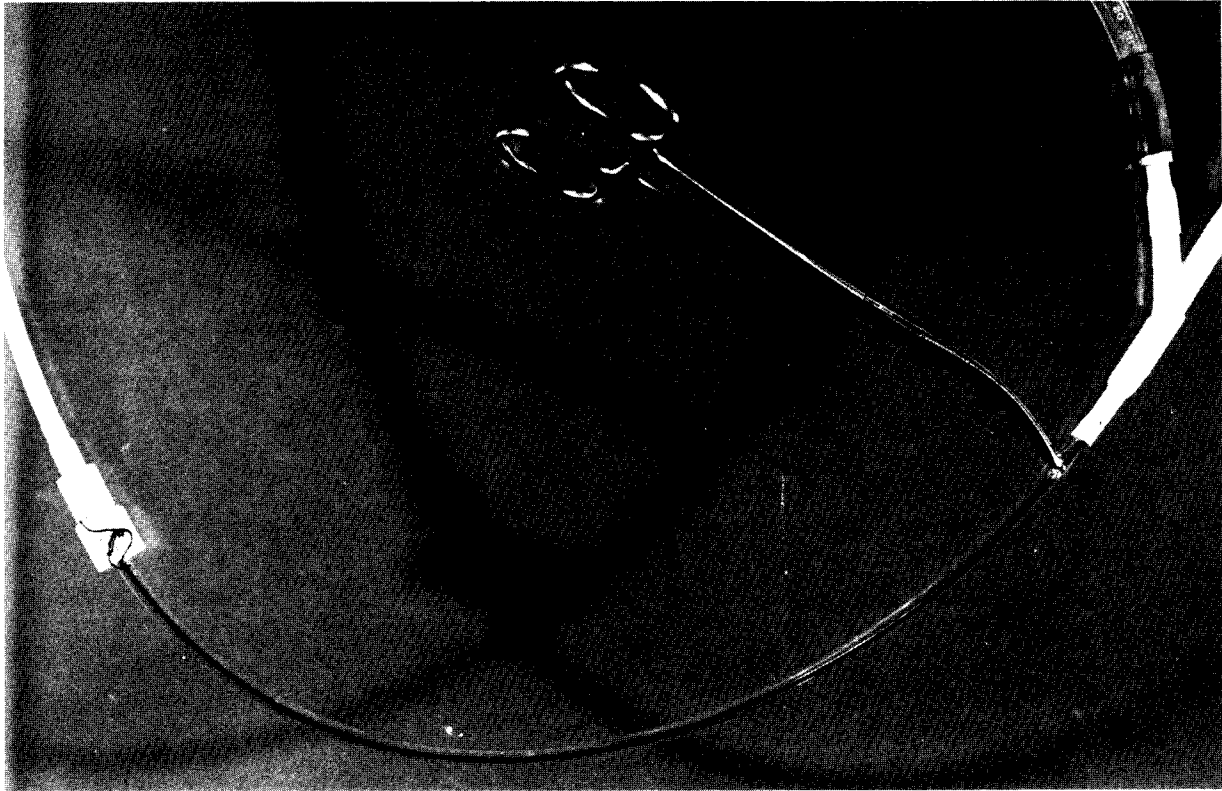
Approximately 45 minutes after bypass a disposable sucker tip was contaminated and removed from the table. When the sucker tip tubing for the new tip was attached to the drapes, the balloon catheter was also partially clamped, causing the drastic change in diastolic augmentation. The console, being in the "manual" mode did not alarm. However, the perfusionist immediately noticed the change, and proceeded to correct the problem by locating and removing the clamp. Balloon augmentation was resumed and the console put in the "auto" mode. A few minutes later the surgeon requested that non-assisted arterial pressure be recorded and the balloon augmentation was turned off. Simultaneously, the drapes were removed from the patient. The towel clamp that had originally penetrated the catheter was also removed, causing a substantial leak. It should be noted that when the Model 10 console^a is turned off and subsequently turned back on again, the "auto" mode automatically reverts to the "manual" mode and must be manually activated to the "auto" mode after "manual" augmentation has been established. In this case, balloon augmentation was attempted with no response. Upon close visual inspection the two holes made by the towel clamp were found. Due to the unusual site of the puncture and the hemodynamic stability of the patient, the balloon was removed.

FIGURE 1. Kelly clamp partially occluding balloon catheter.

This complication may have been avoided if there was better visibility of the balloon catheter during surgery, as well as more awareness of the operating room personnel to these potential hazards. Since the incident, we are now exposing the greatest length of balloon catheter possible for constant visibility and as has been our past prac-

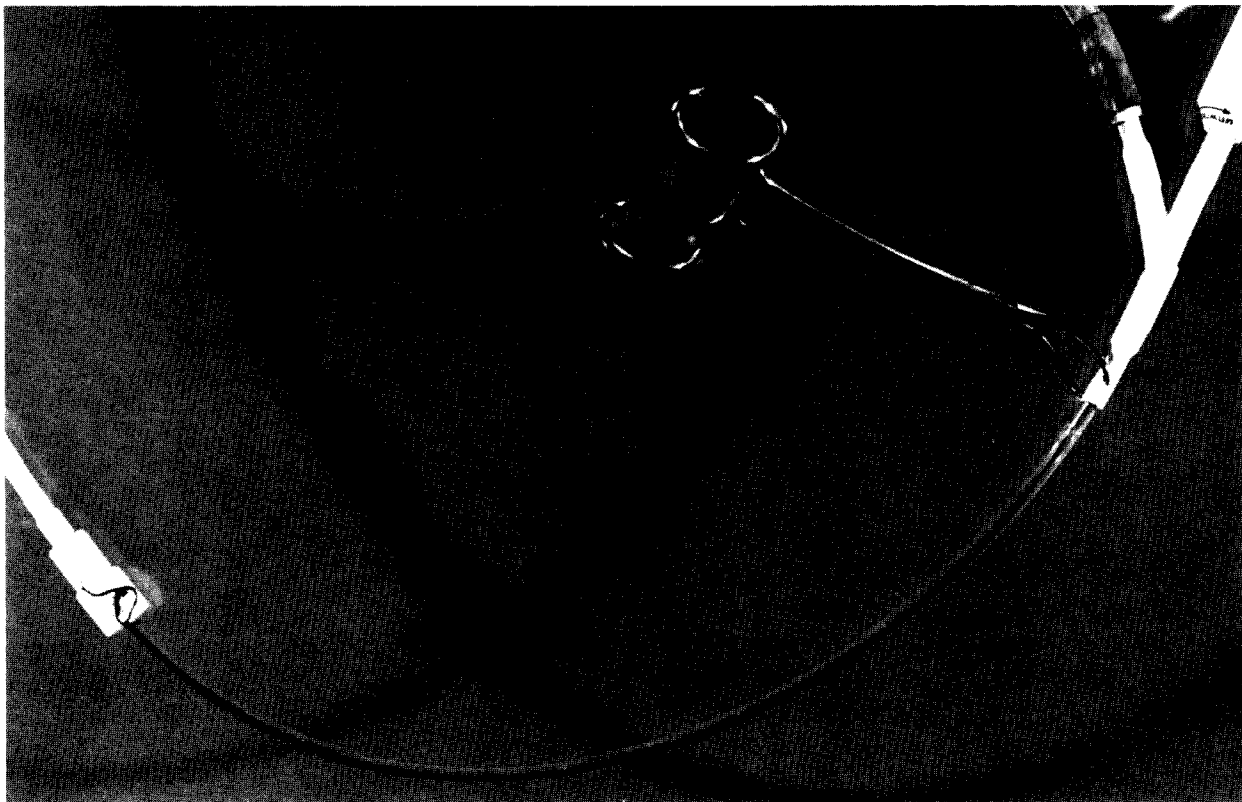
We were not aware that a towel clamp had penetrated the balloon catheter during draping. Apparently because of the sealing effect of the towel clamp itself in the catheter, the systolic and diastolic augmentation were unaffected.

FIGURE 2. Penetration of balloon catheter with towel clamp.
