**Case Report**

***Cracked Acrylic Ventricular Assist Devices after Using a Doppler Stethoscope and Ultrasound Transmission Gel to Predict Impending Pump Failure: A Case Report***

Verna E. Nelson, BS, CCP

St. Louis University Health Sciences Center Perfusion Department, St. Louis, MO

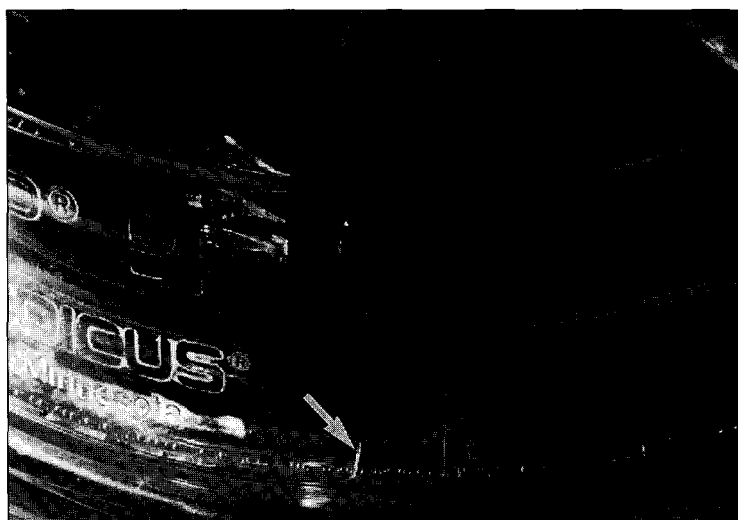
**Figure 1A: Right ventricular assist device. Arrow pointing to noticed initial crack.**

A Medasonics<sup>d</sup> 5MHz doppler stethoscope and Parker<sup>e</sup> Aquasonic® 100 ultrasound transmission gel were placed near each VAD pump backplate above the housing of the magnet and bearings. Each VAD was listened to every hour to compare for any sound change that may relate to the beginning of a pump failure. The gross hematuria cleared with the use of diuretics and no sound change was detected for the first 12 hours. At this time a small crack was found on the RVAD cone where the gel and stethoscope were used (Figures 1A and 1B). No blood leakage was noted and sterile bone wax was applied to the RVAD.

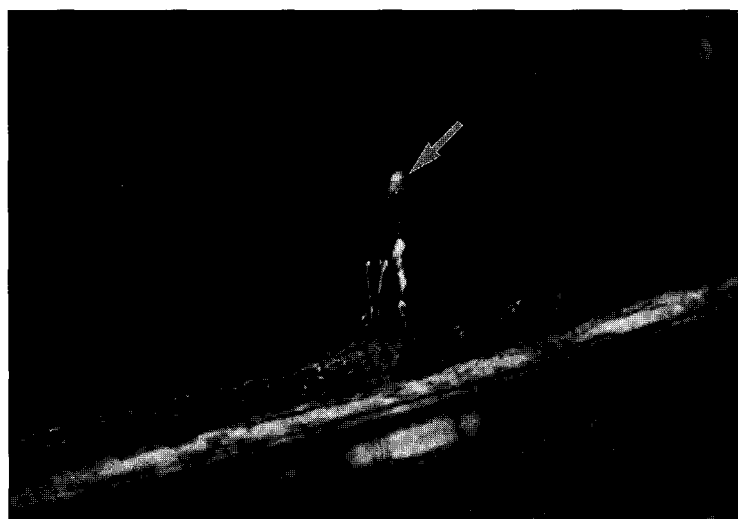
**1B: Enlarged photo of crack with areas of crazing noticed at seam of device. Crack does not extend through to the blood side of device.**

According to the manufacturer of the gel, it is a nonflammable, noncorrosive, temperature stable, aqueous gel that does not contain alcohol or formaldehyde. The gel is also non-injurious to transducers and nonirritating to the skin. Composition of this gel includes reverse osmosis water, humectant, polymer, preservatives to include propyl paraben and methyl paraben, water soluble fragrance and FD&C color (12). Upon further investigation into the cracking of the BiVADs, this clinical institution was able to reproduce the cracks and crazing on the VAD by using only the ultrasound gel. The manufacturer of the centrifugal pumps was able to reproduce the cracks and crazing with the gel also. A burst test was done and consisted of running the VAD at the highest revolutions per minute and placing the gel on every external part of the plastic. Actual leaking and separation of the blood component of the VAD from the pump backplate occurred. The cause of the cracking, crazing, and leaking of the VAD was due to the ultrasound gel.

In the future, manufacturers of acrylic plastics used in extracorporeal circuitry should include ultrasound gel as a hazardous substance. The exact ingredient in the gel that causes this cracking is unidentified. Based on our experience, no chemical or any substance should be placed on ventricular assist devices.

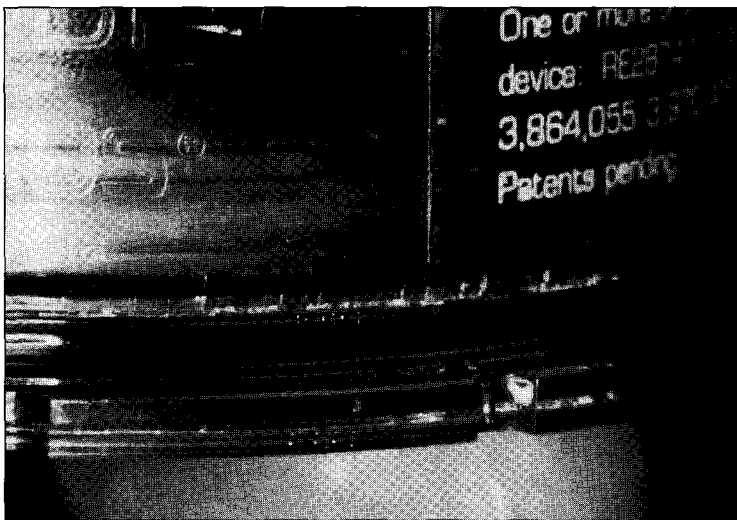
Upon rinsing and examining the BiVADs, small splinter-like cracks, crazing and larger cracks were noticed on both devices (Figures 2A and 2B). The cracks were specifically located where the gel and stethoscope were used to listen to the devices.

**Figure 2A: Left Ventricular Assist Device. Multiple cracks seen at seam of device. Bubbles are part of normal manufacturing process of attachment of backplate to the blood pump.**
