## Case Report

# Possible Fire Hazard Caused by Mismatching Electrical Chargers With the Incorrect Device Within the Operating Room

### OVERVIEW

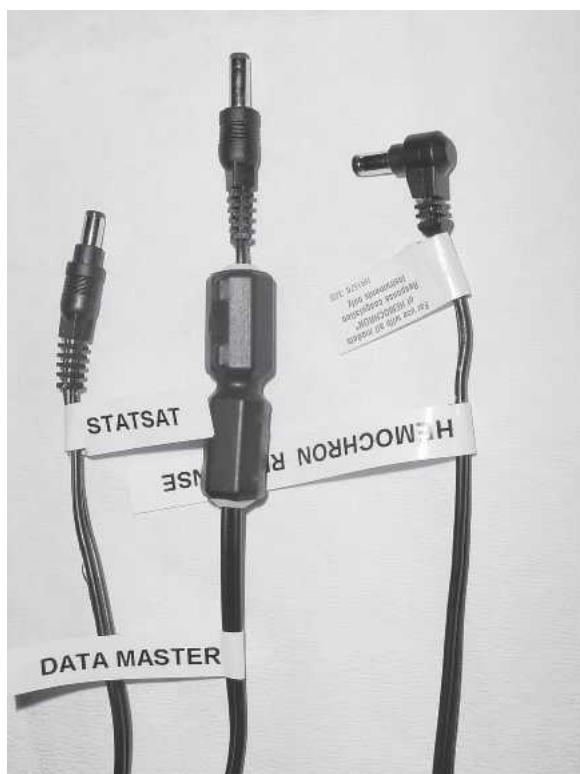
The device was withdrawn from service and subsequently examined. The same temperature alert and shut down was observed. However, on testing the device using battery power only, no temperature alarm was seen, and temperature was steady at 37°C. At this point, the charger was examined and found to be delivering 18 V instead of the required 12 V. This caused excessive heat build-up in the circuitry, with consequential device shut down. The device was checked using the correct 12-V charger, which resulted in no further problems, and was subsequently put back in service.

rent (DC) sockets (internal diameter, 2.5 mm; external diameter, 5.5 mm) but had different outputs varying from 7.5 to 18 V (Figure 1). These devices are the Hemochron Response, Dideco Datamaster in line PO<sub>2</sub> monitor (Sorin Italia, Mirandola, Italy), and the Gish Statsat (Gish Biomedical, Irvine, CA) venous saturation device. Because the charging plug will fit all these devices, the potential exists for the 18 V to be connected to a device that only requires 7.5 V. There is a potential risk of fire should these devices be allowed to charge unsupervised overnight. It should be noted that the Gish Statsat does not have any indication as to the power rating on the back plate. This device has the highest voltage requirement (18 V).

**Figure 1.** These devices have similar device plug tops but all have different voltage outputs.

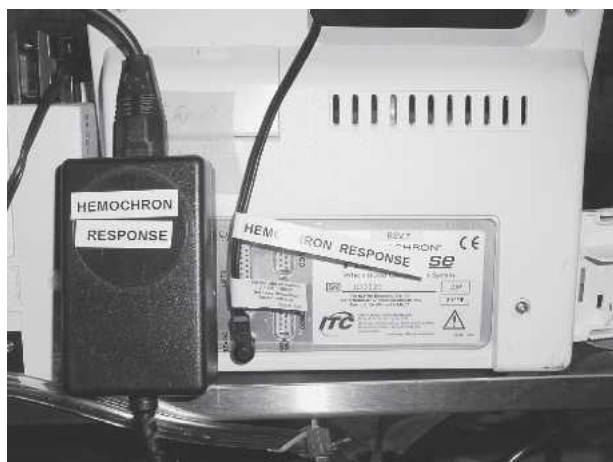
**Figure 2.** Labeling of transformer and plug tops.

Having informed the hospital risk management department, the above occurrence was also reported to the Biomedical engineering section for hospital wide attention. An asset number is to be attached to all transformers and charging plugs, which should match when using the device. We also labeled (Figure 2) all transformers and plug ends with DYMO Letra Tag white washable plastic labels (Dymo bvba, Sint-Niklaas, Belgium). The Biomedical Department also ascertained that the above report is a hospital-wide problem and can be dangerous when devices are loaned from one department to another.

In conclusion, it is imperative that a labeling system be put in place for each of the charging systems, both on the transformer and the plug, used in operating theaters to minimize the risk of fire, device destruction, or patient harm.
