A Single-Center Experience with Luminal Venous Cannulae Obstruction Caused by Clot Formation during Bypass

Department of Cardiac Surgery, Boston Children's Hospital, Boston, Massachusetts

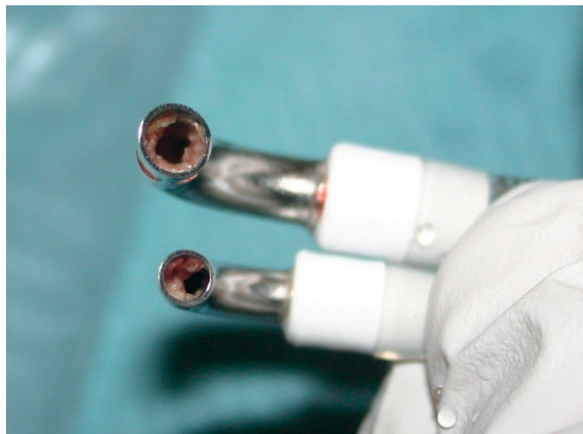
Our institution experienced two cases over an 11-month period in 2011 with significantly decreased venous return during bypass, which was ultimately found to be the result of luminal cannula obstruction. Figure 1 shows the obstruction from our first observed case. It was initially surmised

that these obstructing events were unique and perhaps related to patient hypercoagulability, heparin management, or isolated cannulae production lot events. We were concerned enough after the two initial cases that we began inspecting all venous cannulae postbypass at the end of 2011. We used our NRE monitoring program to document all cases that had venous cannulae luminal obstructions whether venous return was affected on bypass or not. From January through August 2012, we documented partial luminal obstruction of the angled metal tip in 33 cannulae used in 21 patients. We did not experience cannula clotting events in any other venous cannulae used. Only one case, in August 2012, exhibited venous return poor enough to require cannula change-out on bypass. Throughout the venous cannulae monitoring period, we sent several samples of the luminal obstruction to our pathology laboratory. Each pathology report was consistent in that the obstruction was newly formed fibrin clot without tissue attached. Furthermore, all of the observed clots were similar in appearance and varied in size only.

Figure 1. First observed venous cannulae clots.

Throughout the spring and summer of 2012, the manufacturer identified the specification gaps that were coincident with their new metal tip supplier, qualified an improved production method to address the specification differences, which likely led to the luminal clots, and began production with the new method for some of the product line. We began receiving 12-, 14-, and 16-Fr angled metal-tipped cannulae produced under the new method in September 2012. We continue to inspect cannulae postbypass. We have had one incident of venous cannula clot requiring change-out on bypass since receiving the newly produced metal tips. This was with a 14-Fr cannula in December 2012. The incident was reported through MedSun and directly to the manufacturer. The manufacturer inspected that particular metal tip and found it did not meet their new specification requirements. Additional lot inspections by the manufacturer have been implemented to prevent such a recurrence. To note, the entire product line is reportedly using the new method of production and so lots produced in December 2012 and later will have the updated metal tips, according to the manufacturer. We continue to inspect all venous cannulae postbypass and recommend this practice.
