# Unexplained Obstruction of an Integrated Cardiotomy Filter During Cardiopulmonary Bypass

Cory M. Alwardt, PhD, CCP; Donald S. Wilson, MS, CCP; Octavio E. Pajaro, MD, PhD

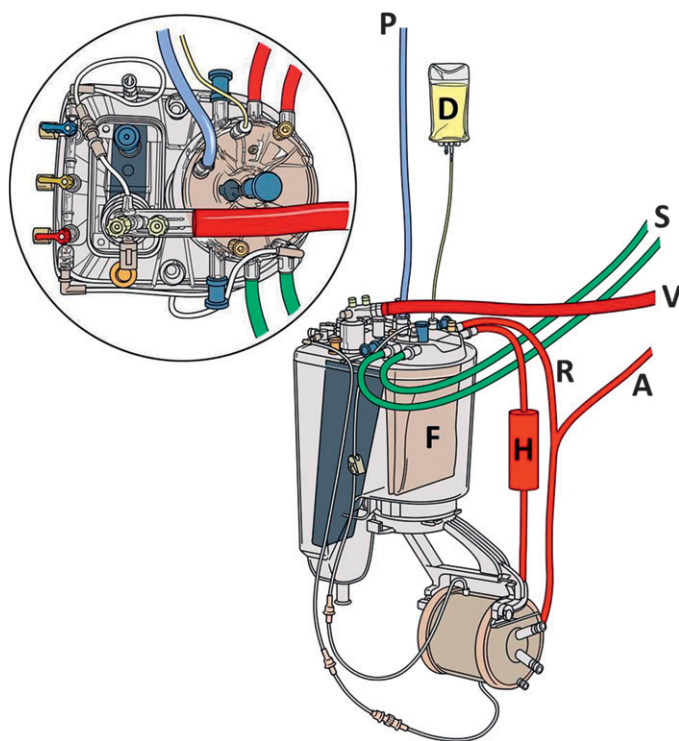
Several minutes after uneventful initiation of CPB, the aortic cross clamp was placed and the heart was excised in preparation for the donor heart. Approximately an hour after placement of the aortic cross clamp and unremarkable CPB, the perfusionist noticed that the continuous drip rate of phenylephrine that was entering the integrated cardiectomy filter had unexpectedly slowed.

**Figure 1.** Original circuit configuration. A = patient arterial line, D = phenylephrine drip line, F = integrated cardiectomy filter, H = hemoconcentrator, P = priming line, R = recirculation line, S = pump suction (sucker/vent).

Regarding the configuration of our circuit, it is routine in our practice that the hemoconcentrator shunt enters the cardiomy reservoir directly (Figure 1). Although this configuration results an increased air/blood interface that could theoretically cause increased hemolysis, we prefer the configuration to adding a high-pressure shunt to the venous line as not to interfere in any way with venous drainage. We have used this same configuration over many years with no incidents or notable hemolysis; therefore, it would be unlikely that any sort of increased load on the filter due to the configuration would be to blame for the filter obstruction.

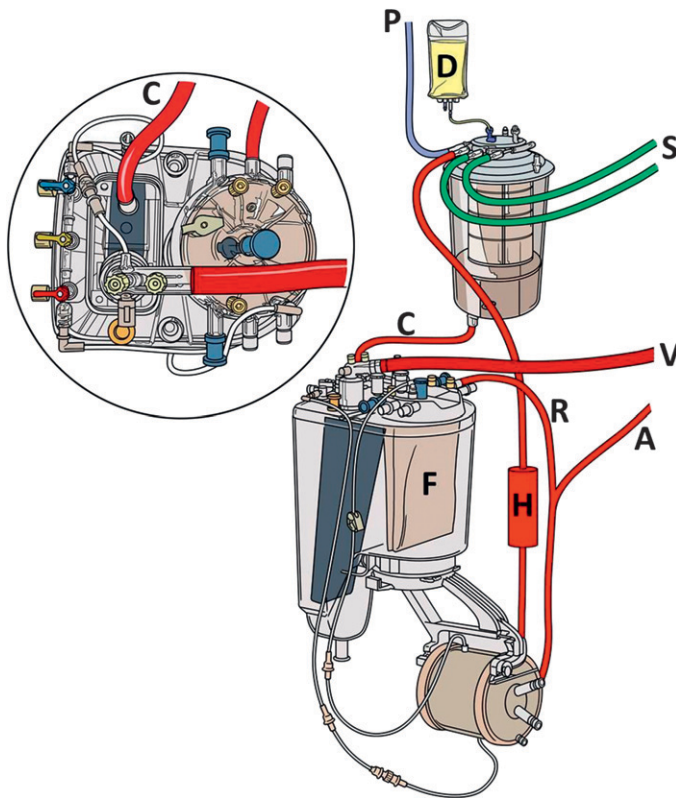
**Figure 2.** Adapted circuit configuration. A = patient arterial line, C = circuit connection to the external cardiomy reservoir, D = phenylephrine drip line, F = integrated cardiomy filter, H = hemoconcentrator, P = priming line, R = recirculation line, S = pump suction (sucker/vent).

Communication between the surgeon and perfusionist confirmed the surgeon's need for a properly functioning pump sucker and vent, therefore routing sucker/vent blood to a cell salvage reservoir was not appropriate. The perfusionist then retrieved a 4 L hard-shell blood collection reservoir with 40-micron filter (EL404, Medtronic, Minneapolis, MN) and secured it to the heart lung machine just above the level of the main venous reservoir to ensure gravity drainage. This reservoir allowed for appropriate circuit adaptation (Figure 2). The pump suckers were disconnected from the obstructed cardiectomy filter suction ports, extended using 1/4" straight connections and 1/4" tubing, then rerouted to the new reservoir. The prime line, hemoconcentrator shunt, and phenylephrine drip line were also transferred to ensure full functionality of the CPB circuit. The recirculation line was not relocated since it is generally kept clamped throughout CPB. The outlet of the new reservoir was then connected to the 3/8" auxiliary port entering the venous filter to allow drainage into the venous reservoir. The 3/8" tubing between the new reservoir and the auxiliary port was generally kept clamped, and unclamped only when volume had accumulated to prevent excess air from entering the venous filter. Although the phenylephrine drip was transferred and reconnected, dosing was done using a syringe into the venous line via the sampling

manifold. This configuration successfully bypassed the obstructed filter and allowed the full use of pump suckers, prime lines, and hemoconcentration without introducing excess air into the venous reservoir. CPB was maintained in a normal fashion, aside from the change in configuration. There was never any disruption in support of the patient in terms of blood flow or proper gas exchange throughout the entirety of this incident.
