Case Report

Use of Volatile Anesthetic Agent in Extracorporeal Circuit as a Cause of Break in Polycarbonate Connector—Lessons Learnt

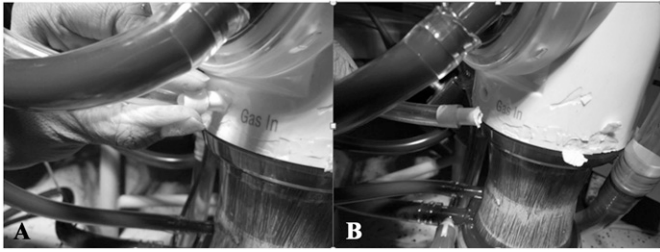
Figure 1. (A) Handholding of disconnected oxygen inlet line. (B) Reaction of isoflurane with polyvinyl chloride with disconnected gas inlet line.

After a careful review of the incident, it was found that the most likely cause of the fractured gas inlet connector was exposure of the inlet to liquid isoflurane during filling of the vaporizer.

In our case, while filling the isoflurane vaporizer by the perfusionist, some of the isoflurane liquid came in contact with the PVC gas connector which led to melting of the connector and its disconnection from the oxygenator at the inlet site. It was concluded that some liquid isoflurane accidentally spilled from the vaporizer because of vigorous shaking of the container. There was no blood leak from the oxygenator, so the situation was managed by manually holding the inlet line to the oxygenator.

After this incident, the isoflurane vaporizer was moved to an alternate location on the heart–lung machine to prevent a similar incident from occurring again.
