Alterations in Pre/Post Oxygenator Flows Due to Fibrin Deposition in the CardioHelp System—A Case Report

Tyler Wahl, MHS, CCP;* Angela Stokes, MHS, MBA, CCP;* Caleb Varner, MSP, CCP, FPP;* Burak Zeybek, MD;† Amit Bardia, MD†

Presented at AmSECT 60th International Conference 2022, Phoenix, Arizona, April 6–10, 2022.

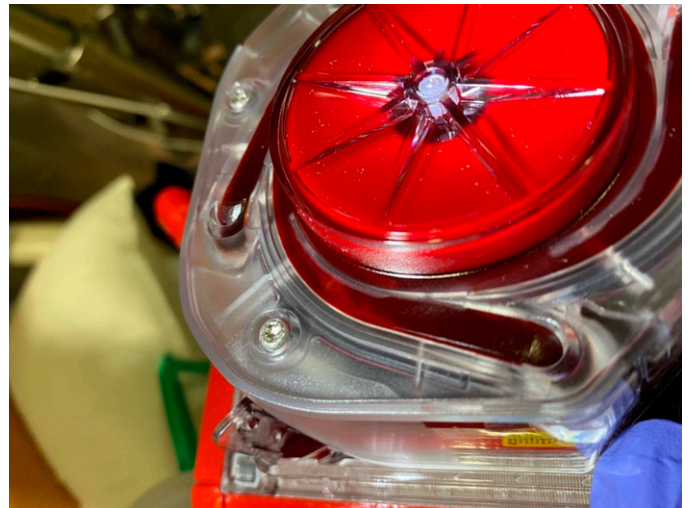
Over the following days, the patient continued to decompensate requiring increased inotrope support for decreased right heart function in addition to continually decreasing oxygenation despite maximum ECMO/Ventilator support. On ECMO day 12, the patient was terminally weaned from ECMO. Upon examination of the CardioHelp disposable, fibrin and clot were noted in the flutes of the centrifugal pump. These formations fall distal the P_{Ven} transducer but proximal to the $P_{\text{int}}/P_{\text{Art}}$ transducers, see Figure 1. A reduction in flow at this junction would yield the changes in flow and pressure noted in Table 1.

Figure 1. CardioHelp Centrifugal Head Clot formation.

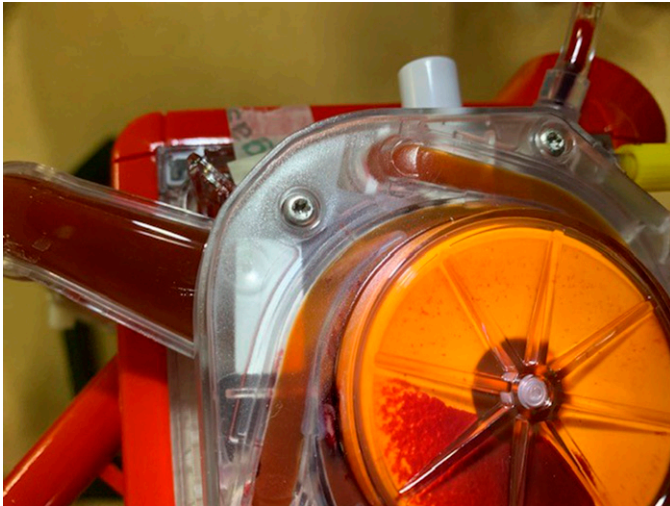
Figure 2. CardioHelp Centrifugal Head Clot formation.

Fibrin and clot burden on ECMO circuits and oxygenators are unavoidable. With other ECMO consoles such as the Centrimag (Thoratec Corp, Pleasanton, CA) console, the oxygenator and centrifugal head are separate components. This allows thrombus build-up to be seen pre and post oxygenator as well as on the centrifugal head. The CardioHelp console combines the oxygenator and centrifugal head for a compact design. The limitation of this design is the inability to visualize clot formation pre-membrane or on the centrifugal head without detaching the unit from the console. Additionally, the design of the centrifugal head is different than other commonly available devices. Typical centrifugal heads have one large inlet and one large outlet. The CardioHelp's centrifugal head has one large inlet and four

small outlets which has the benefit of evenly distributing the blood flow across the membrane; however, the disadvantage of this design is the fibrin buildup on the smaller diameter outlets (Figure 2).

Clinical scenarios such as planned procedures and bleeding often necessitate holding anticoagulation in patients on ECMO support (4). Surveillance of oxygenators during ongoing ECMO therapy to predict clot formation to avoid critical situations such as circuit failure and thrombus embolization is thus pertinent (5,6). Although monitoring circuit pressures may serve as a guide to ongoing hemodynamic changes, they cannot be solely relied upon since they may be misleading as seen in this case scenario. A judicious multidisciplinary approach incorporating all the elements of patient's clinical status, circuit pressures and visual examination of the circuit is recommended for optimal patient outcomes.
