Case Reports

Dermabond as a Novel Solution for Needle-Hole Repair in Arterial Cannula while on Extracorporeal Membrane Oxygenation Therapy

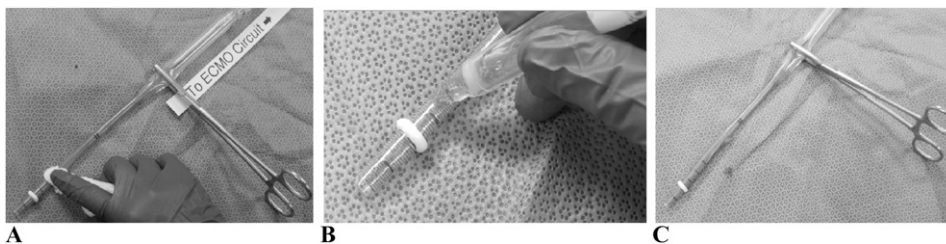
Figure 1. Simulation of steps performed for cannula repair. (A) Cleaning and removing debris from the cannula before applying Dermabond. (B) Applying Dermabond to the affected area of the cannula and allowing a cure time. (C) Wrapping Ioban around the cannula to provide additional support for the Dermabond.

An attempt was made to apply bone wax (Ethicon, Somerville, NJ) over the hole, but that approach did not stop the bleeding out of the side of the cannula. A repair attempt was made with Dermabond (Ethicon) as a reasonable alternative to an almost impossible cannula exchange. It was felt that adhesion and curing could not be completed with high arterial line pressures and ongoing flow in the circuit. This patient had an ECMO circuit internal pressure of 240 mmHg in the arterial line with a blood flow of 4.5 L/min. When the trial off from ECMO was performed, the bleeding from the needle hole stopped with the temporary cessation of circuit flow. Therefore, ECMO was temporarily turned off to establish a lower pressure and no flow in the arterial line to allow adhesion and curing of the glue before going back on ECMO (Figure 1). The cannula was dried and freed of debris before applying the Dermabond to the needle-hole area of the cannula. The Dermabond was allowed to cure for 60 seconds. The cannula was then circumferentially wrapped with Ioban (3M, St. Paul, MN) to provide additional support for the Dermabond. ECMO was resumed after 90 seconds of flow suspension.
